SALT RUN RESERVOIR DAM

NDI No. PA 00392

PHASE I INSPECTION REPORT
NATIONAL DAM INSPECTION PROGRAM

February 1979

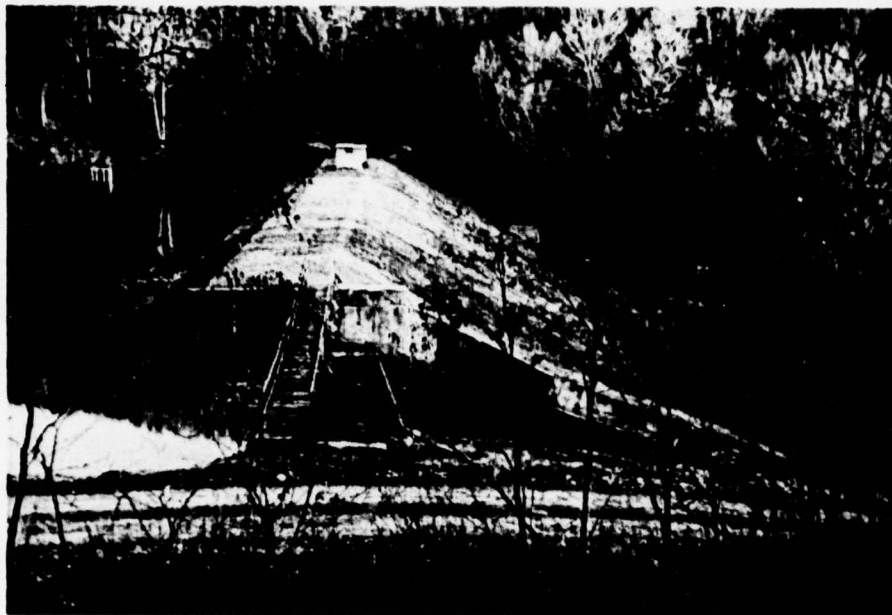
Overall View from Spillway (Right) Hillside

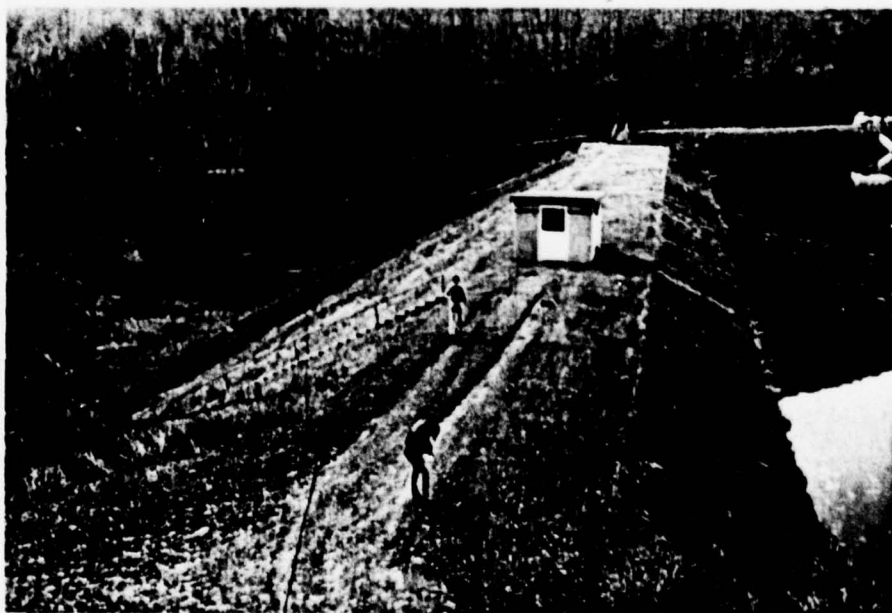
Overall View from Hillside (Left) Opposite of Spillway

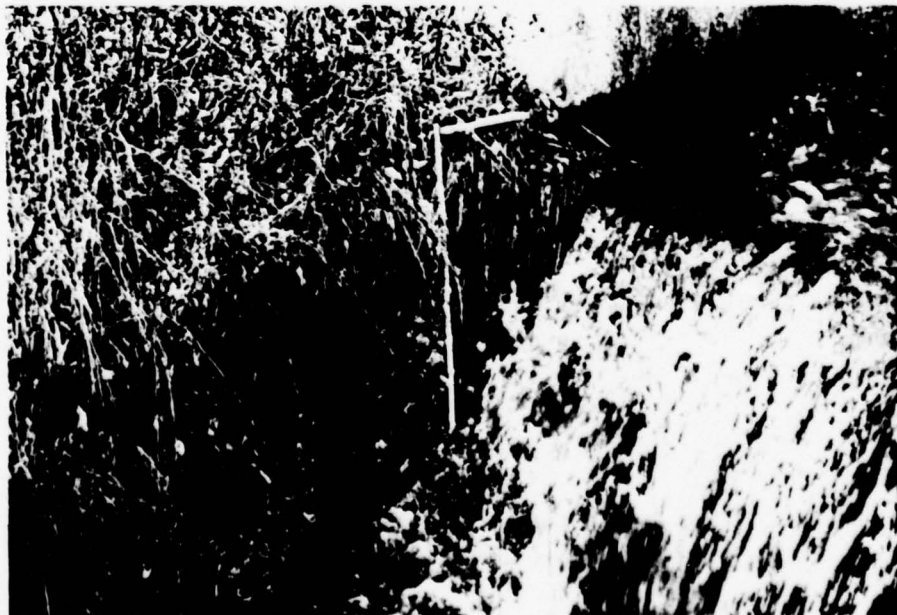
The end of the right training wall of the spillway and the lower right channel slab are undermined. According to the design drawings, the downstream channel slab of the spillway was constructed on in situ or embankment materials. The downstream end of the slab was observed to be constructed on a hand-placed, hard shale, rock fragment foundation. No drainage outlets or filters (transition zones) are shown on the design drawings for the spillway slab. Therefore, the potential for undermining and failure of the slab exists as evidenced by the observed undermining of the end of the right side of the spillway. The undermining should be repaired soon.

SPILLWAY FOUNDATION	The spillway crest is constructed on a concrete core wall. The spillway channel slab rests on in situ or embankment materials. The downstream end of the spillway channel slab rests on a constructed shale foundation. The end of the right spillway training wall and channel slab is undermined.	Proper drainage outlets and filters have not been provided. With the present design, potential for undermining and failure of the slab exists. The undermining at the right end should be repaired.

PHOTO 6. View of Right End of Spillway Showing Undermining

- g) Provide copies of the emergency procedures to all operational personnel and instruct the personnel on their use.
- 4) Repair the undermined area at the end of the right side of the spillway.
